Short Report

## Automobile door entrapment – A different form of vehicle-related crush asphyxia

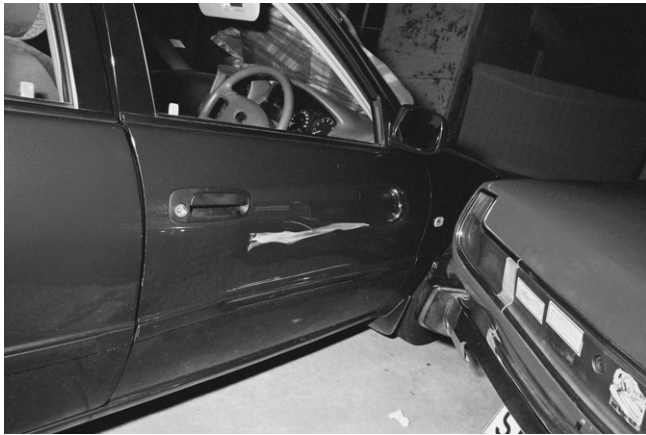
The possibility of inflicted injury was raised given the unusual nature of the death and a crime scene investigation was initiated. Linear horizontal scratches were present along the driver's door that reflected the area of impact with the back left hand corner of the adjacent parked vehicle (Fig. 1). The body showed areas of linear blanching of the side of the face, the lower chest and the back (Fig. 2), with an oblique linear indentation on the back of the right calf. The distance from the ground to the doorsill was 260 mm and from the ground to the roof was 1360 mm. The pressure markings on the side of the face corresponded to the edge of the roof, the markings on the calf to the position of the doorsill and the markings on the back to the edge of the doorframe. Markings on the chest corresponded to projections on the inside of the door. There was no trauma to the face, neck, hands, mouth, teeth or genitalia. At autopsy there was congestion of the face with occasional conjunctival petechiae. Compressive injury to

Fig. 1. Scratches along the door of the victim's motor vehicle in case 1 where it had impacted with the rear of a second stationary vehicle on the left. Paint flakes along the scratches matched the second car. The 58-year-old victim was found wedged between the half-opened car door and frame. (Note: in Australia vehicles are right hand drive).

cerns that there may have been involvement of another person in the death. However, careful examination of injuries at the scene and correlation with features of the car frame and door soon confirmed the position of the body at death, the absence of any other inflicted injuries, and the likely accidental nature of the death.

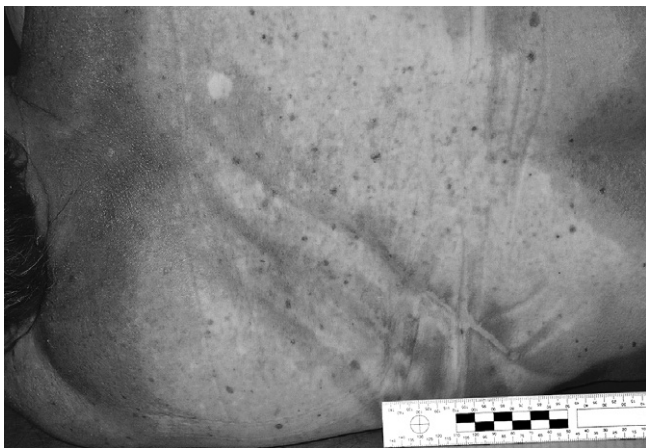
Fig. 2. Linear markings on the back of the victim in case 1 corresponded to the car frame.
